# INSPECTION REPORT

For the Property at:  
**123 STONE WAY**  
GERMANTOWN, WI 53022

Prepared for: PAUL VAN ENGEN  
Inspection Date: Monday, March 16, 2020  
Prepared by: Paul VanEngen

RE: Report No. 1003, v.0  
123 Stone Way  
Germantown, WI  
53022

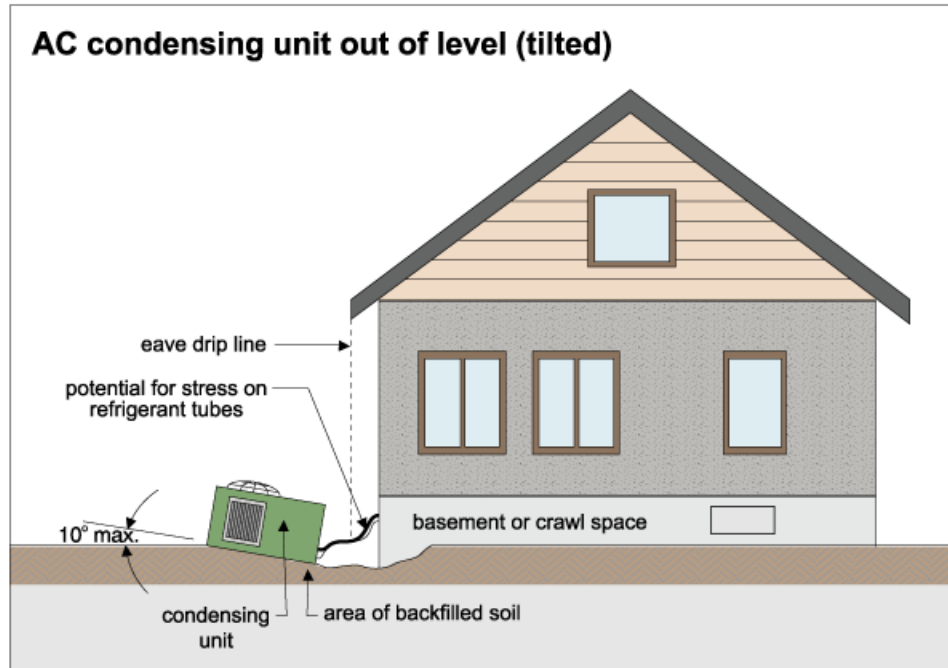
### AIR CONDITIONING \ Compressor

**Condition:** • Out of level

**Implication(s):** Reduced system life expectancy | Damage to equipment

**Task:** Improve
